City of
Santa Rosa

June 10, 2022

PARKS

PRIORITIZATION REPORT

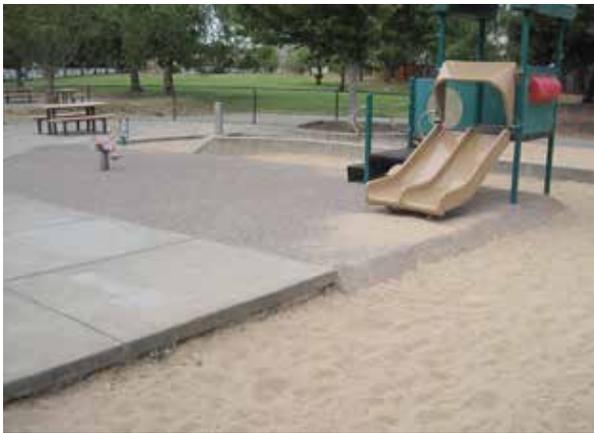
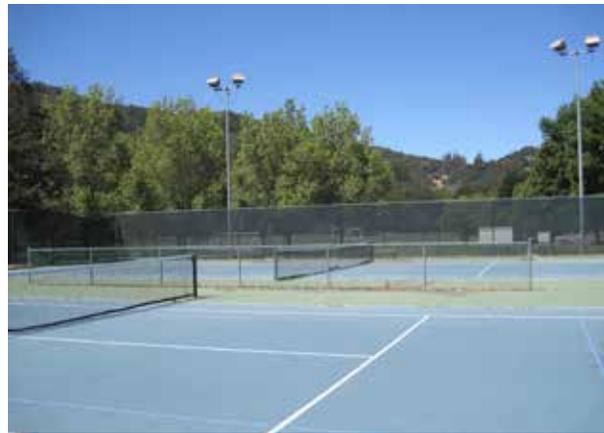
Figure 3: Example Amenities vs Assets

Amenity = Playground
 Assets = Equipment
 Curb
 Surfacing
 Furnishings
 Barriers
 Signs

Amenity = Tennis Courts
 Assets = Lighting
 Equipment
 Surfacing
 Furnishings
 Barriers
 Signs

Prior to site investigations, an asset and amenity list was developed as well as an established rating criteria for each type of asset, see Figures 9 and 10. Amenities are defined as attributes of a park that have a designated use, such as sports fields, playgrounds, and dog parks. Assets are defined as specific components that make up a park amenity. For an amenity such as a playground, the assets would be identified as the play equipment, play surfacing, perimeter fencing, and so forth, see Figure 3 for examples.

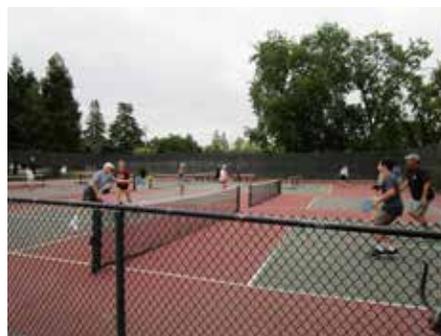
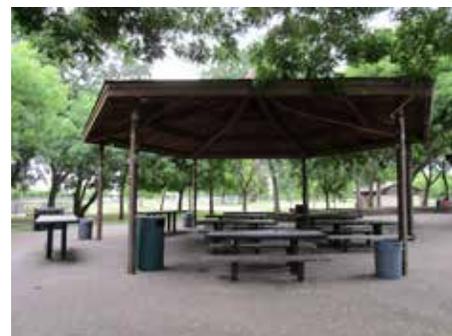
The critical condition amenities within the park are the playground and volleyball court. The playground rubber surfacing is deteriorating and peeling back in some areas and the playground equipment is showing significant wear. At the volleyball court, the net is missing and the sand surfacing has significant weed growth.

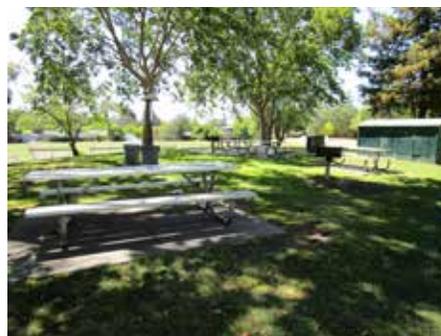
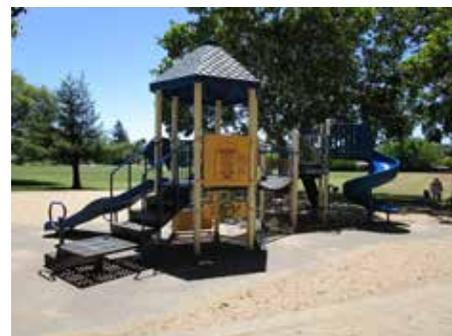
There are no critical condition amenities within the park, though the presence of temporary trash receptacles indicates a demand for more permanent receptacles.

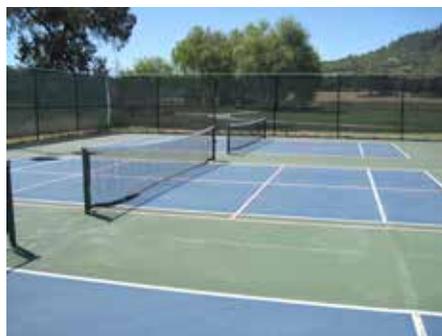
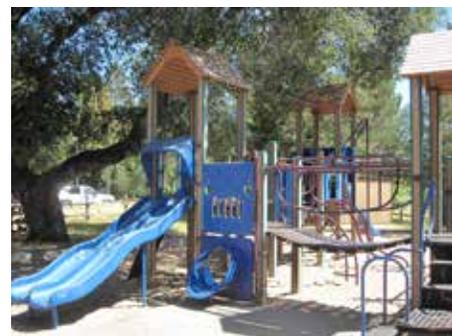
The critical condition amenities within the park are the tennis courts and structures. Tennis courts #9 and #10 have cracking throughout the court surfacing. The storage shed near tennis court #1 has been vandalized.

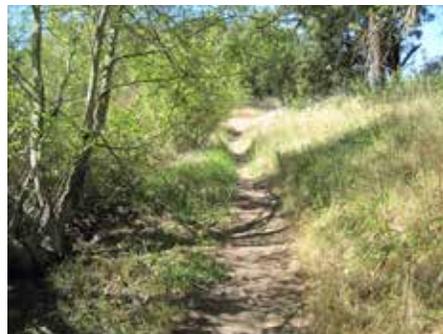
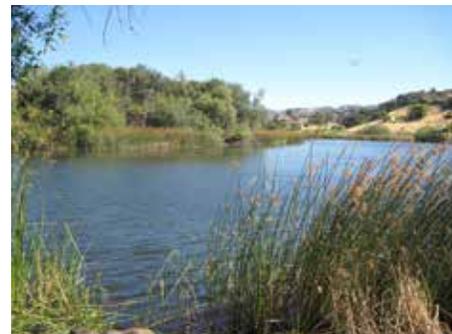
The critical condition amenity within the park is the irrigation system, which was damaged by the 2017 wildfire.

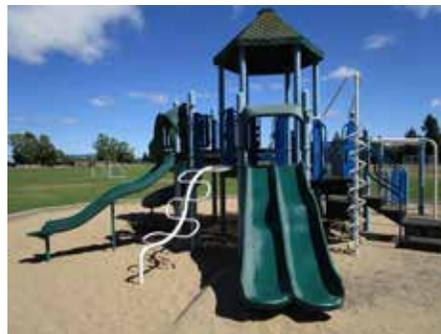
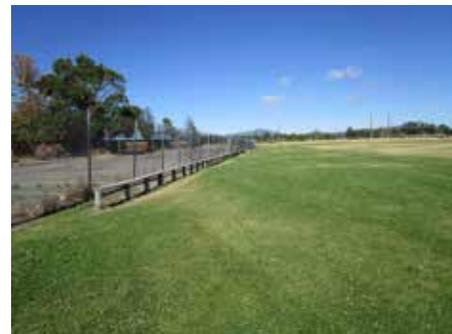
The critical condition amenities within the park are the landscape, hardscape, and rugby field. The landscape has a substantial amount of weeds, the hardscape has deterioration in the asphalt pavement, and the rugby field has issues with irrigation coverage and furnishings that are worn.

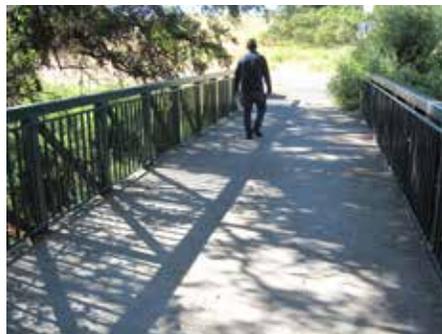
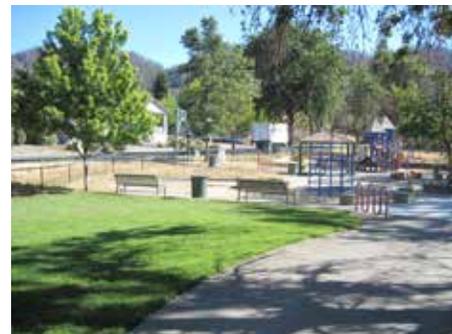
The critical condition amenity is the park's trail, which has significant cracking in the asphalt, moderate weed growth, and damaged fencing.

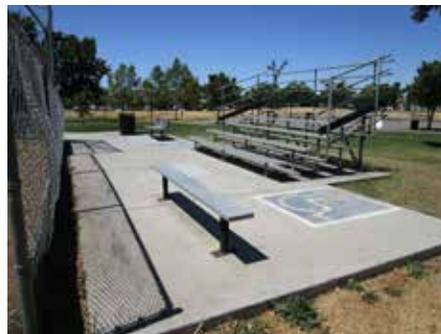
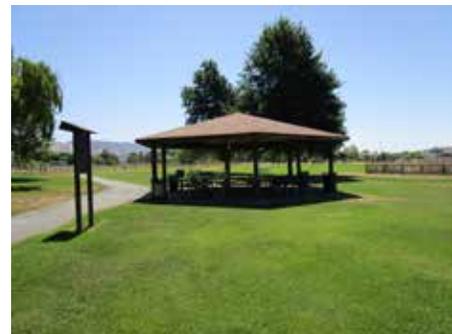
The critical condition amenities within the park are the general hardscape and the gravel parking lot. The asphalt has major cracking, while the parking lot has uneven surfacing and substantial pot holes.

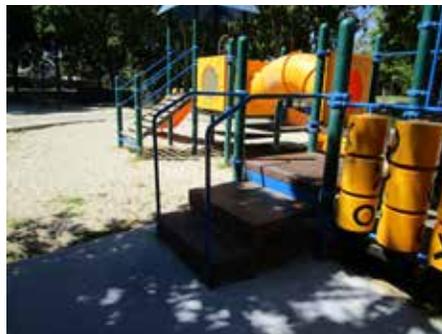
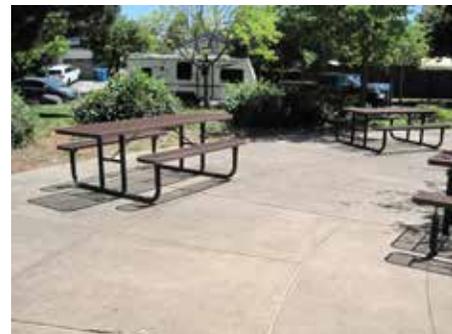
RANKING MATRIX - COLGAN CREEK PARK

The overall condition of the park is adequate aside from a few deficient amenities. Colgan Creek Park does not have recreation programming, has very high play value, and has a few significantly non-compliant ADA features.

The critical condition amenities within the park are the playground and trails. The playground equipment shows signs of excessive wear and broken components with weeds growing in the sand surfacing. The trails have major cracking throughout the asphalt pavement.

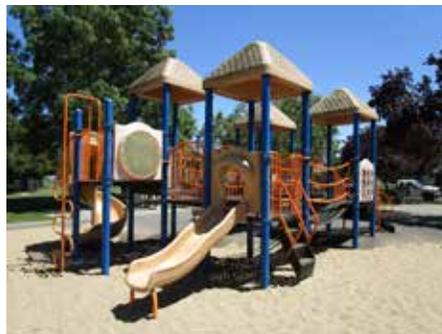
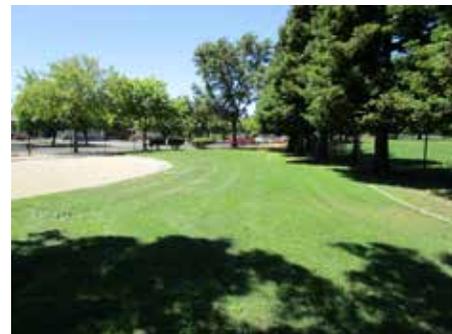
RANKING MATRIX - COOK SCHOOL PARK

The overall condition of the park is adequate, and a majority of the amenities are fully functional. Cook School Park does not have recreation programming, has low play value, and has a few significantly non-compliant ADA features.

The critical condition amenities within the park are the signage, which is illegible due to wear, and a deficient quantity of trash receptacles.

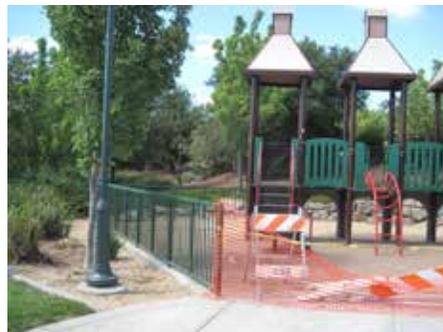
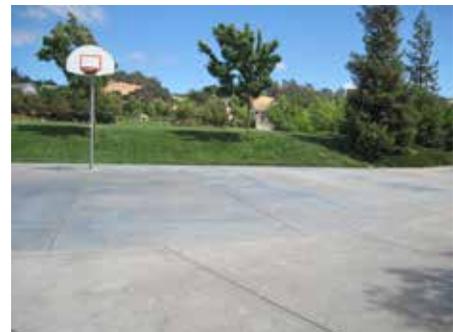
RANKING MATRIX - DAUENHAUER PARK

The overall condition of the park is very good, a majority of the amenities are functional, and the park is not anticipated to need major improvements in the near-term. Dauenhauer Park does not have recreation programming, has very high play value, and has a few significantly non-compliant ADA features.

There are no critical condition amenities at the park, though the basketball court lacks court striping.

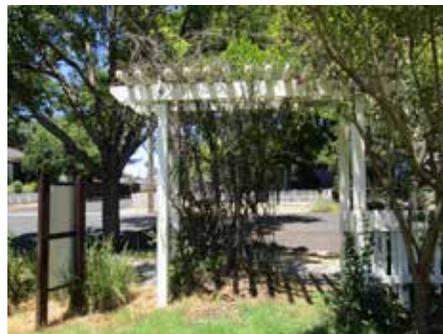
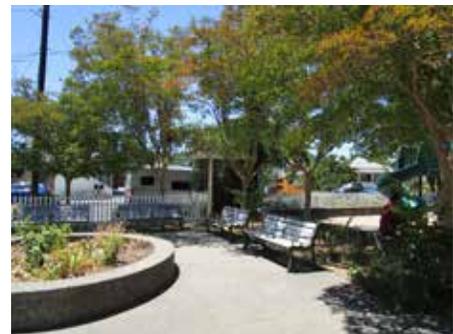
RANKING MATRIX - DEMEO PARK

The overall condition of the park is adequate, and a majority of the amenities are fully functional. DeMeo Park has minimal recreation programming, very high play value, and has a few significantly non-compliant ADA features.

There are no critical condition amenities within the park, though there appears to be a deficient quantity of trash receptacles.

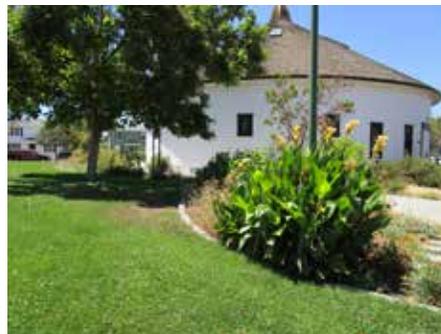
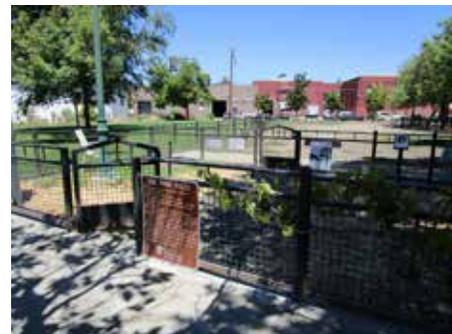
RANKING MATRIX - DETURK PARK

The overall condition of the park is adequate, and a majority of the amenities are fully functional. DeTurk Park does not have recreation programming apart from the barn, has moderate play value, and has a few significantly non-compliant ADA features.

The critical condition amenities within the park are the signage, which is illegible due to wear, and a deficient quantity of trash receptacles.

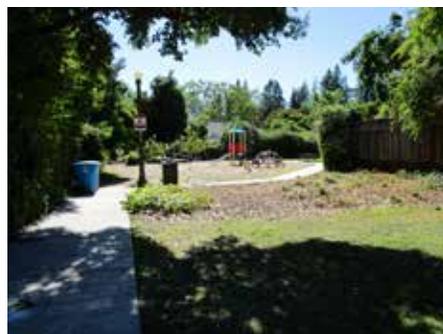
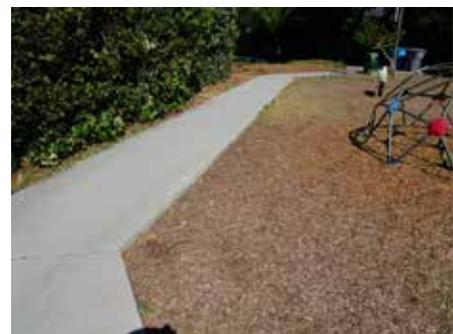
RANKING MATRIX - EASTSIDE PARK

The overall condition of the park is adequate, and a majority of the amenities are fully functional. Eastside Park does not have recreation programming, has very high play value, and has a few significantly non-compliant ADA features.

The critical condition amenities within the park are the signage, which is illegible due to wear, and a deficient quantity of trash receptacles.

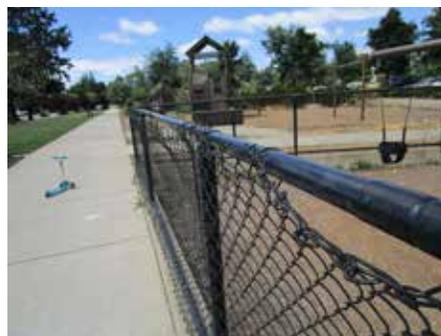
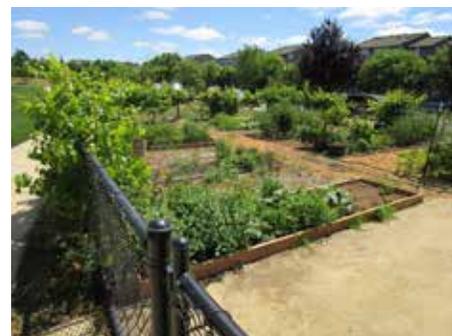
RANKING MATRIX - FINALI PARK

The overall condition of the park is very good, a majority of the amenities are functional, and the park is not anticipated to need major improvements in the near-term. Finali Park does not have recreation programming, has very high play value, and does not have non-compliant features identified by the 2013 and 2016 ADA assessments.

There are no critical conditions amenities at this park. However, the wood fiber at the playgrounds will soon require replenishing and the ornamental planting areas have weeds and require additional mulch.

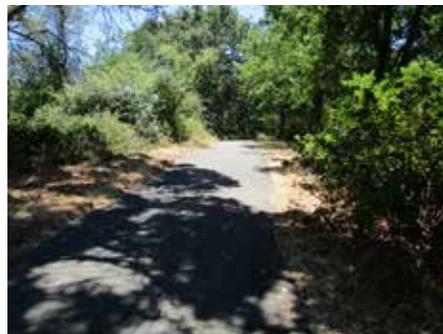
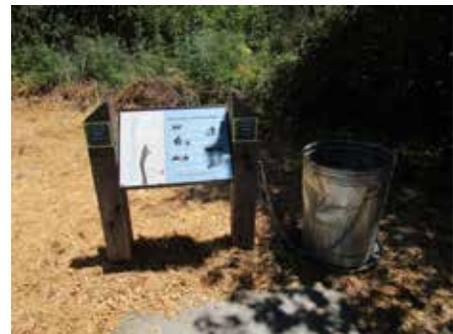
RANKING MATRIX - FLAT ROCK PARK

The overall condition of the park is poor. Flat Rock Park does not have recreation programming, has low play value, and has a few significantly non-compliant ADA features.

The critical condition amenities within the park include deficient trash receptacles, dense weeds in the natural landscapes, missing bollards, deficient signage and significant cracking in the asphalt pavement.

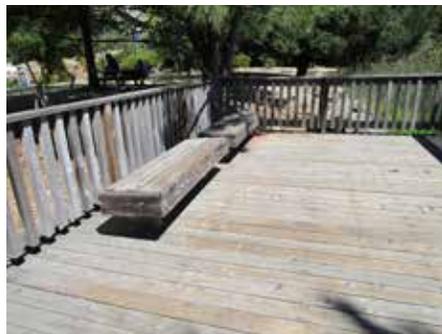
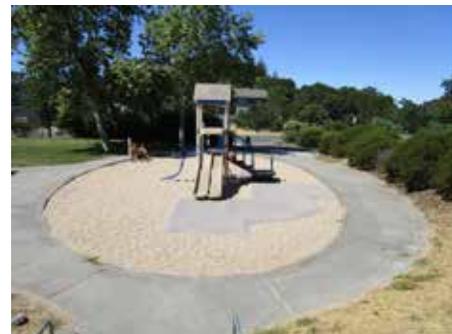
RANKING MATRIX - FRANCES NIELSEN RANCH PARK

The overall condition of the park is good, with a majority of the amenities in good condition. Frances Nielsen Ranch Park does not have recreation programming, has very high play value, and has a few significantly non-compliant ADA features.

There are no critical condition amenities within the park, though the required signage at the playground is deficient.

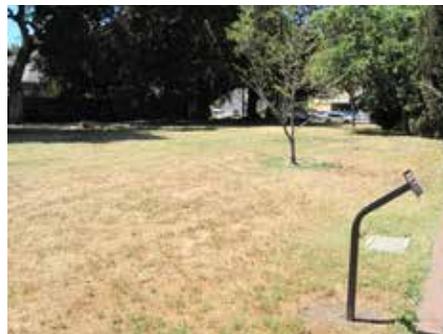
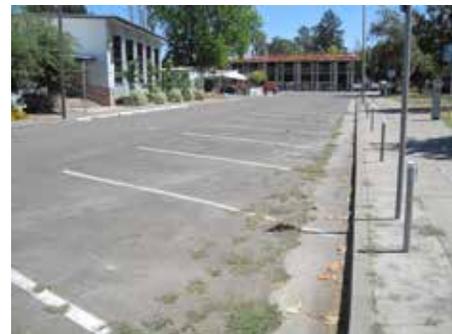
RANKING MATRIX - FREMONT PARK

The overall condition of the park is below adequate, with a few of the amenities broken and not functioning. Fremont Park does not have recreation programming, has low play value, and has a few significantly non-compliant ADA features.

The critical condition amenities within the park are the turf areas, which are experiencing significant dieback, the irrigation system, which does not appear to be operating, and the water feature, which is not functioning.

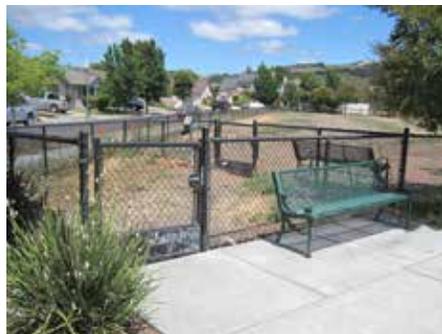
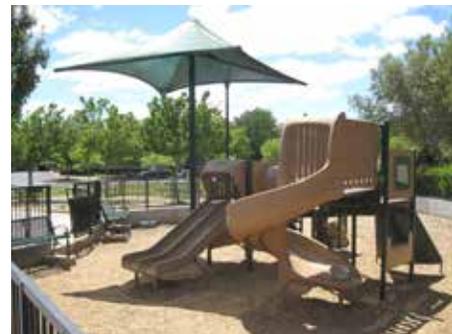
RANKING MATRIX - HARVEST PARK

The overall condition of the park is adequate, and a majority of the amenities are fully functional. Harvest Park does not have recreation programming, has very high play value, and has a few significantly non-compliant ADA features.

The critical condition amenity within the park is the dog park, which has substantial weeds and holes in the mulch surfacing, broken components within the gate, and a deficient quantity of trash receptacles. The playgrounds also have a deficient level of wood fiber surfacing.

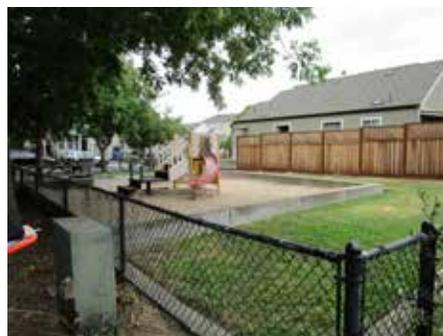
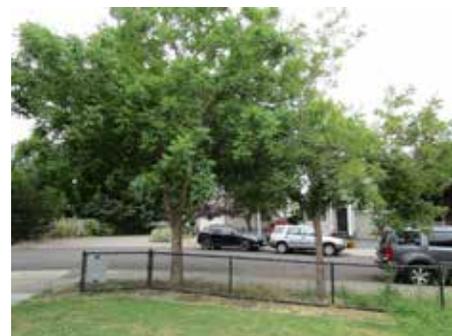
RANKING MATRIX - HAYDN VILLAGE PARK

The overall condition of the park is good, and a majority of the amenities are fully functional. Haydn Park does not have recreation programming, has low play value, and has a few non-compliant ADA features.

The critical condition amenity within the park is the playground equipment, which is showing excessive wear due to its age.

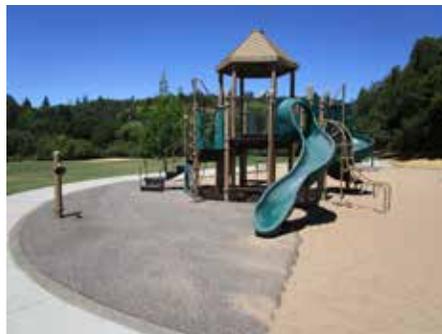
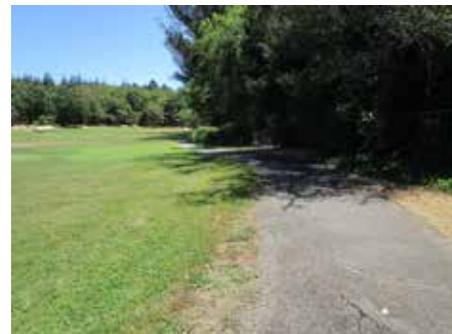
RANKING MATRIX - HIDDEN VALLEY PARK

The overall condition of the park is adequate, and a majority of the amenities are fully functional. Hidden Valley Park does not have recreation programming, has very high play value, and has a few significantly non-compliant ADA features.

There are no critical condition amenities within the park, though the gravel paths on the trails have uneven surfacing, noxious weeds were found within the natural landscape, and trash receptacles appear to be deficient.

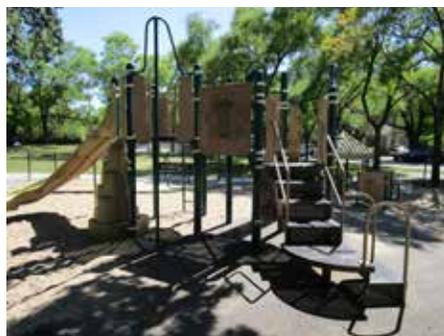
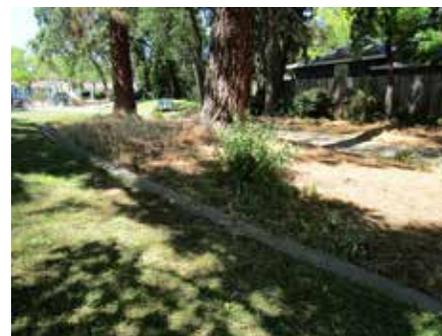
There are no critical condition amenities within the park, though the presence of temporary trash receptacles indicates a deficient number of permanent receptacles in the park.

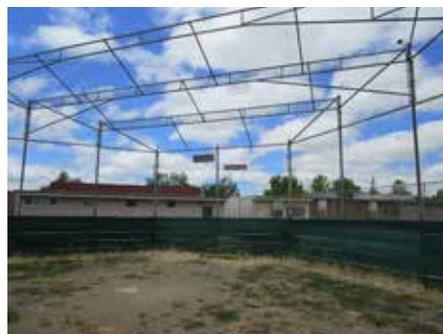
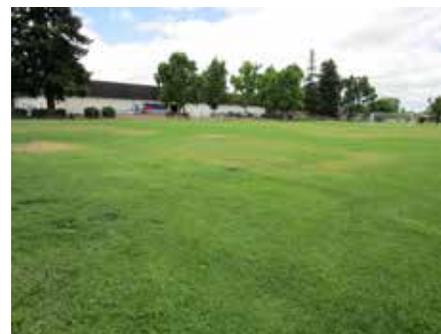
The critical condition amenity within the park is the irrigation system, where extensive dieback is observable within the natural turf. Temporary trash receptacles are present, which suggests a deficient number of permanent receptacles in the park.

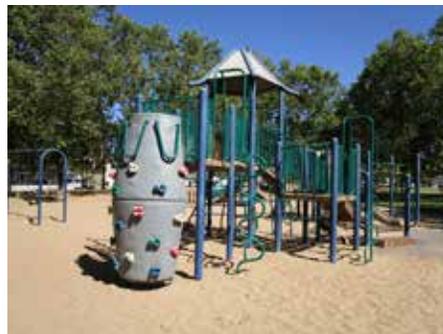
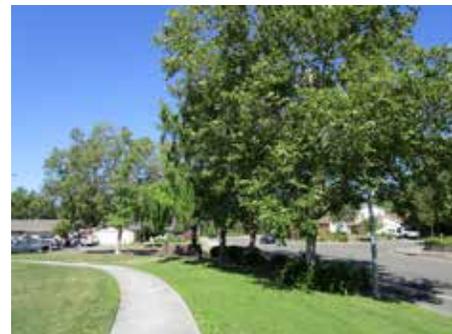
The critical condition amenity within the park is the playground, which has a damaged equipment component and is unsafe to use.

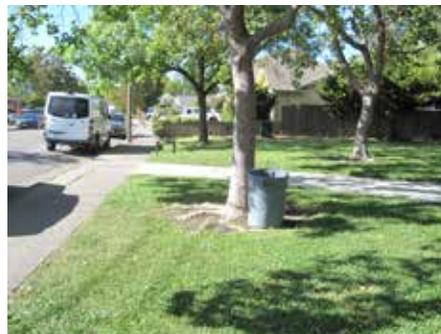
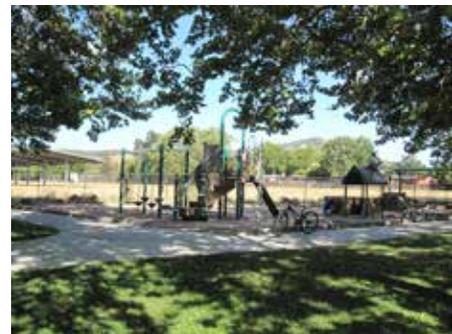
The critical condition amenities within the park are the site furnishings. The presence of temporary trash receptacles suggest a deficient number of permanent receptacles in the park.

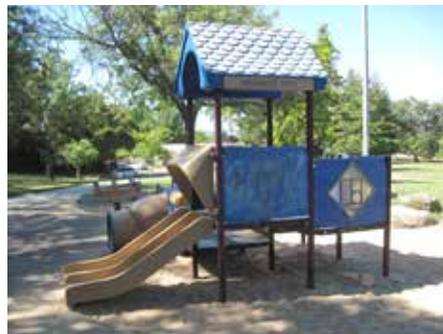
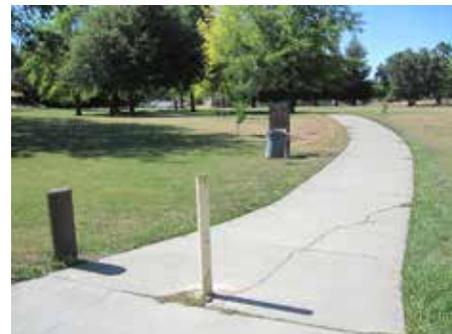
There are no amenities in critical condition at the park. However, the rubber surfacing at the playground is experiencing wear, and the irrigation for the natural turf has coverage issues.

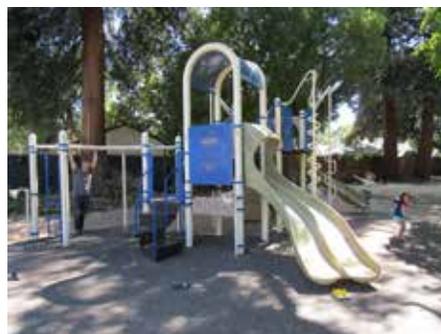
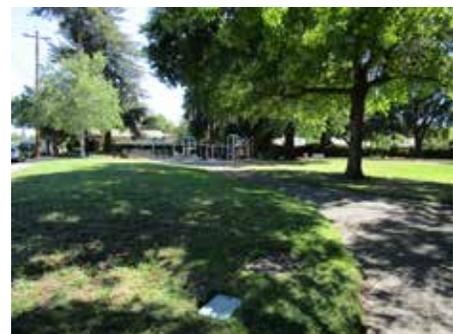
RANKING MATRIX - NORTH PARK

The overall condition of the park is adequate, and a majority of the amenities are fully functional. North Park does not have recreation programming, has very high play value, and has a few significantly non-compliant ADA features.

The critical condition amenity within the park is the hardscape, which has significant cracking and uneven surfaces.

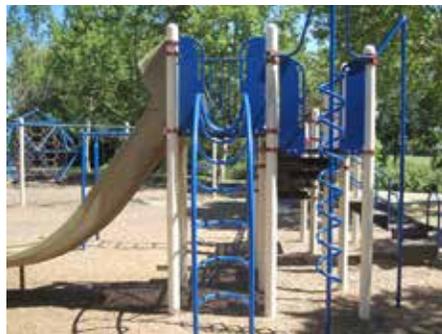
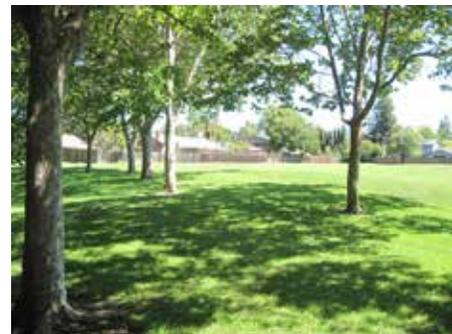
RANKING MATRIX - OAKLAKE GREEN PARK

The overall condition of the park is adequate, and a majority of the amenities are fully functional. Oaklake Green Park does not have recreation programming, has very high play value, and has a few significantly non-compliant ADA features.

The critical condition amenities within the park are the furnishings due to graffiti and deficiency. A number of light poles have been damaged. The playground is below adequate due to insufficient mulch surfacing, damaged play area curb, and drainage issues.

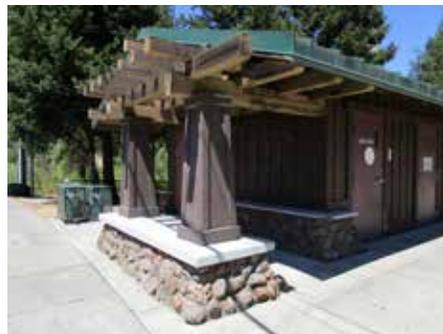
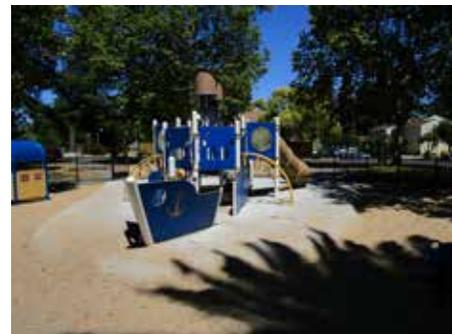
RANKING MATRIX - OLIVE PARK

The overall condition of the park is adequate, and a majority of the amenities are fully functional. Olive Park does not have recreation programming, has very high play value, and has a few significantly non-compliant ADA features.

The critical condition amenities within the park are the site furnishings, due to non-operational drinking fountains and a deficient quantity of trash receptacles.

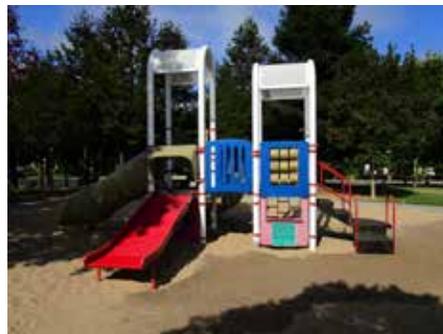
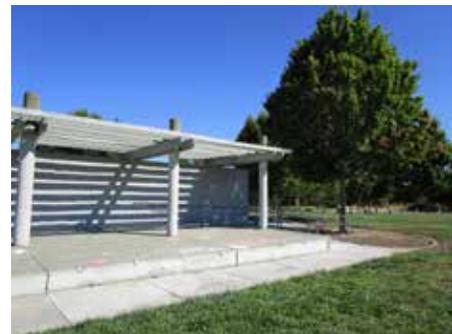
RANKING MATRIX - PEARBLOSSOM PARK

The overall condition of the park is adequate, and a majority of the amenities are fully functional. Pearblossom Park does not have recreation programming, has very high play value, and has a number of significantly non-compliant ADA features.

The park does not have critical condition amenities, though there are portions of the ornamental landscape that are dead or missing and the spray irrigation for the natural turf has coverage issues.

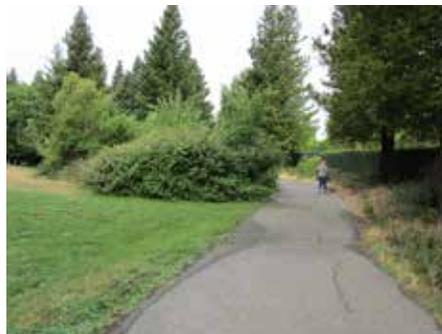
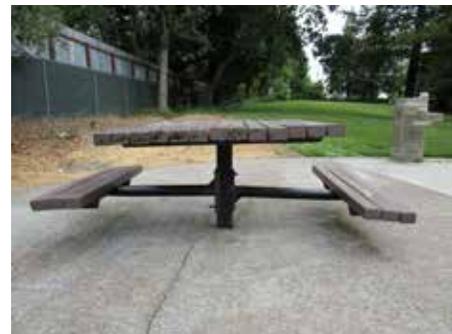
RANKING MATRIX - PETERSON LANE PARK

The overall condition of the park is poor, with a majority of the amenities experiencing excessive wear and deterioration. Peterson Lane Park does not have recreation programming, has very high play value, and has a number of significantly non-compliant ADA features.

The critical condition amenities within the park are the barriers, playground, picnic area, and fitness equipment. The barriers have missing bollards, the playground has low levels of mulch surfacing, the fitness equipment has excessive wear, and the picnic areas have damaged furnishings.

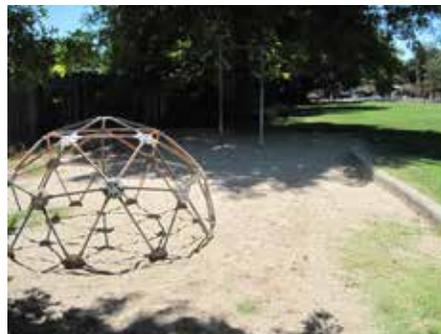
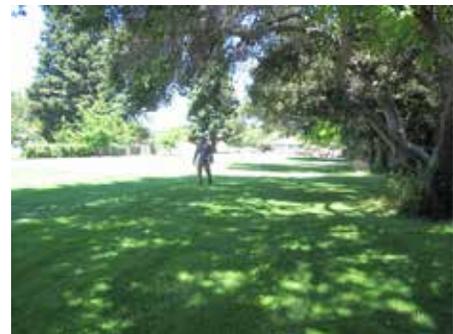
RANKING MATRIX - PETER SPRINGS PARK

The overall condition of the park is adequate, and a majority of the amenities are fully functional. Peter Springs Park has minimal recreation programming, very high play value, and has a few non-compliant ADA features.

The critical condition amenity within the park is the playground, due to the play equipment missing a swing and experiencing excessive wear and the sand surfacing level being low and having weeds.

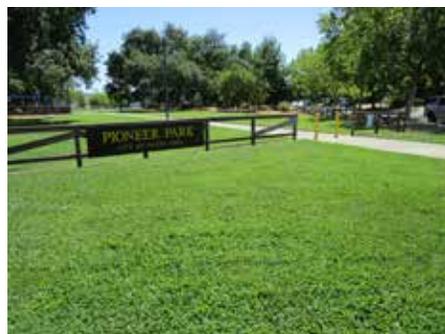
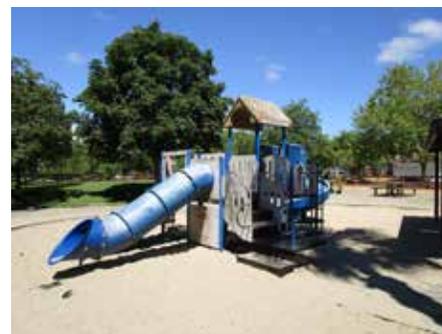
RANKING MATRIX - PIONEER PARK

The overall condition of the park is adequate, and a majority of the amenities are fully functional. Pioneer Park has minimal recreation programming, very high play value, and has a few significantly non-compliant ADA features.

The critical condition amenity within the park is the horseshoe pit, which has deteriorating lumber, aged surfacing, and pavement uplifting due to tree roots.

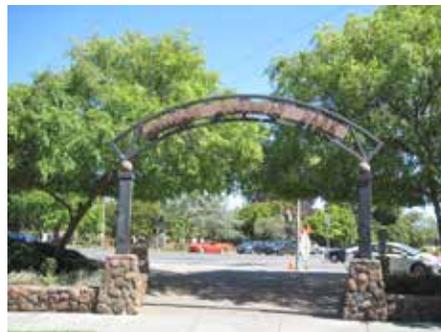
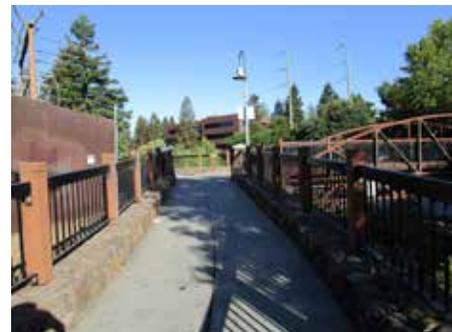
The overall condition of the park is good, with a majority of the amenities being fully functional and fairly new. Prince Gateway Park does not have recreation programming, has moderate play value, and has a minor non-compliant ADA element.

The park does not have critical condition amenities, though the sprayground's UV light was identified as outdated.

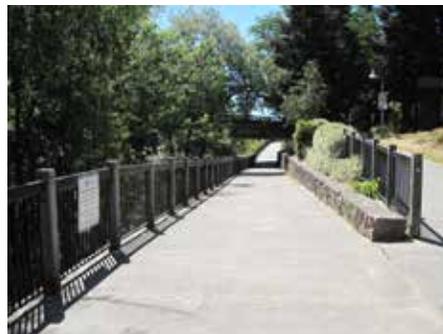
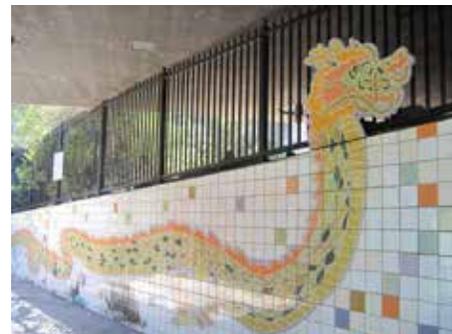
The overall condition of the park is adequate, and a majority of the amenities are fully functional. Prince Memorial Greenway does not have recreation programming, has low play value, and does not have non-compliant features identified by the 2013 and 2016 ADA assessments.

The critical condition amenity within the park is the irrigation system, which was indicated to be non-operational due to the lack of mainline and backflow installation.

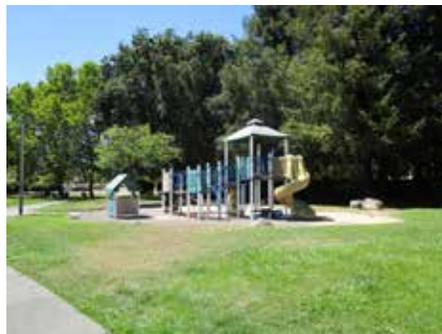
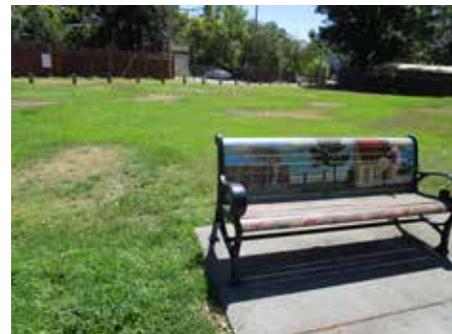
The overall condition of the park is adequate, and a majority of the amenities are fully functional. Rae Street Park does not have recreation programming, has very high play value, and has a few significantly non-compliant ADA features.

There are no critical condition amenities within the park, though the irrigation system is identified by maintenance staff as below adequate.

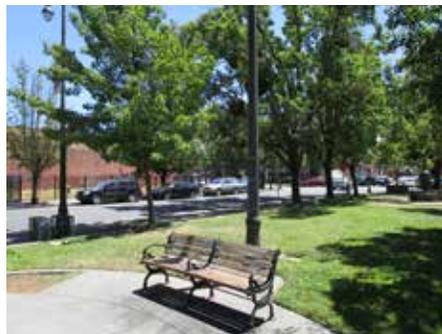
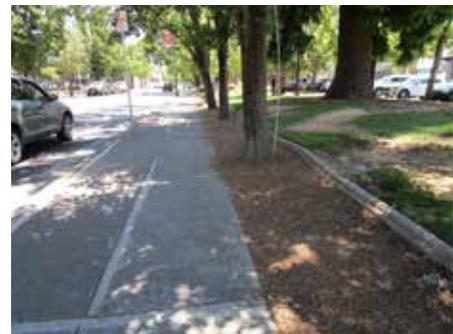
The overall condition of the park is adequate, and a majority of the amenities are fully functional. Railroad Depot Park does not have recreation programming, has low play value, and has a few significantly non-compliant ADA features.

There are no critical condition amenities within the park, though the park rules sign is in a poor location. The monument sign is frequently vandalized.

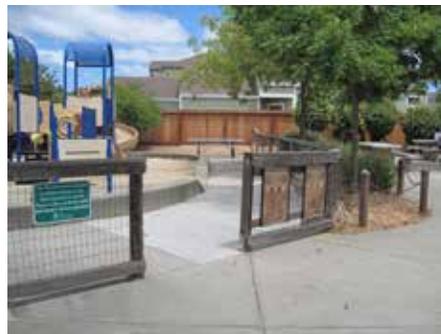
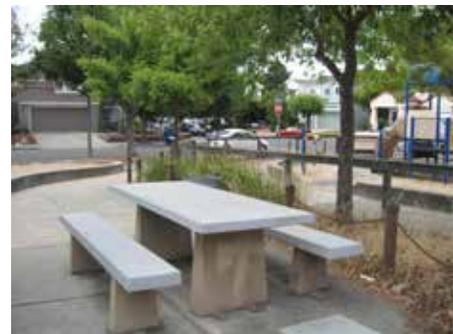
The overall condition of the park is good, and a majority of the amenities are in good condition. Red Hawk Park does not have recreation programming, has very high play value, and has a few significantly non-compliant ADA features.

There are no critical condition amenities within the park though the presence of temporary trash receptacles suggests a deficient number of permanent receptacles in the park.

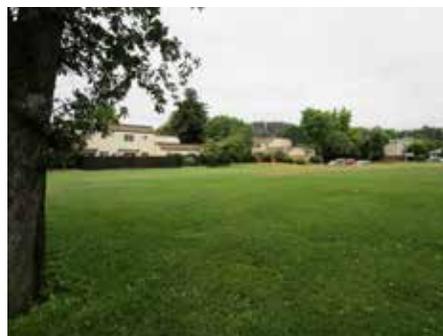
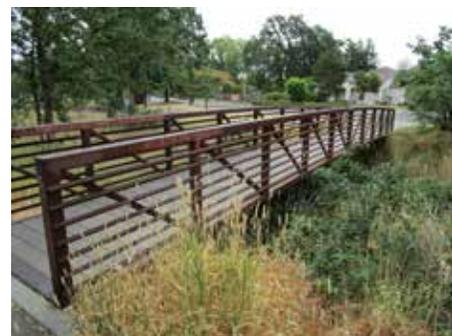
The overall condition of the park is below adequate, with a few amenities broken and not functioning. Rinconada Park does not have recreation programming, has moderate play value, and has a few significantly non-compliant ADA features.

The critical condition amenities within the park are the general hardscape, trail surfacing, and site furnishings. The hardscape has cracking and lifting and there is a deficient number of benches and trash receptacles.

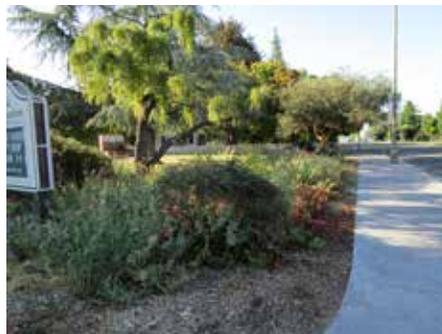
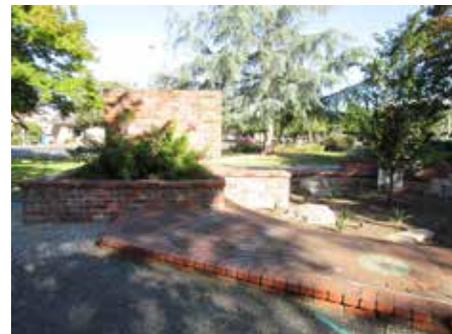
The overall condition of the park is adequate, with some amenities being functional and others being deficient. Sonoma Avenue Park does not have recreation programming, has low play value, and has a number of significantly non-compliant ADA elements.

The critical condition amenities within the park are the irrigation system and the water feature. The irrigation system uses battery powered nodes and has coverage issues, while the water feature is functioning but the water and basin are polluted.

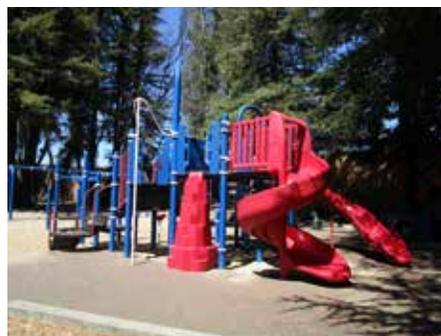
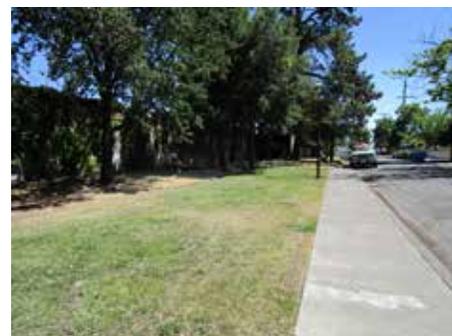
The overall condition of the park is below adequate, with a number of the amenities nearing critical condition. South Davis Park has minimal recreation programming, very high play value, and a number of significantly non-compliant ADA elements.

The critical condition amenity is the basketball court due to the uneven and cracking asphalt surfacing and the heavily-weathered equipment.

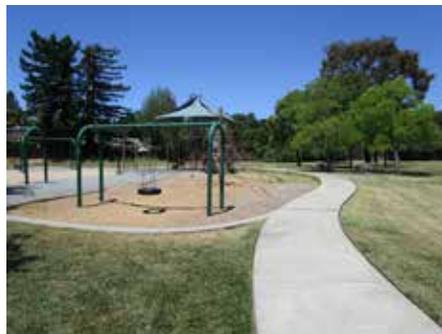
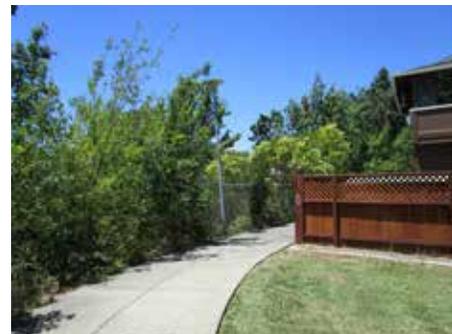
The overall condition of the park is adequate, and a majority of the amenities are fully functional. Steele Lane Park does not have recreation programming, has very high play value, and generally complies with ADA standards with the exception of having a few non-compliant items.

There are no critical condition amenities within the park, but the general irrigation and general landscape are in below adequate condition. The irrigation overspray causes weed growth within the play area, and there are substantial weeds in the landscape areas.

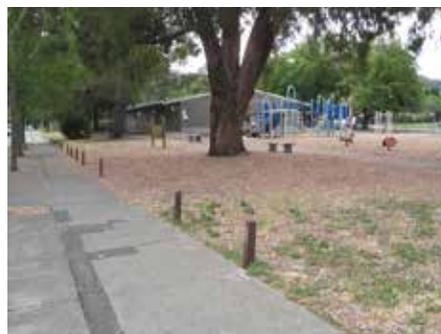
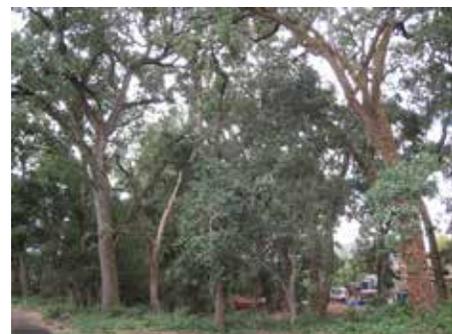
The overall condition of the park is good, and a majority of the amenities are in good condition. Strawberry Park does not have recreation programming, has moderate play value, and does not have non-compliant features identified by the 2013 and 2016 ADA assessments.

There are no critical condition amenities within the park, but the general hardscape is in below adequate condition due to cracking in both the concrete and asphalt pavement.

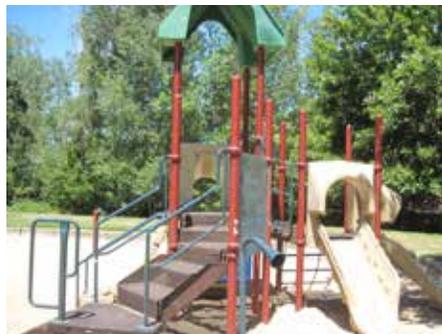
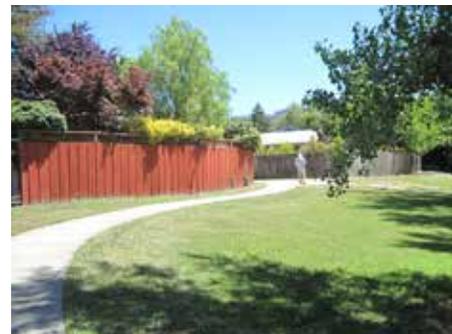
The overall condition of the park is adequate, with a majority of the amenities being functional and a few being in need of servicing. Tanglewood Park does not have recreation programming, has very high play value, and has a few significantly non-compliant ADA elements.

The critical condition amenity within the park is the basketball court, which has major cracking, uneven pavement, faded striping, and severe weed growth within the surfacing.

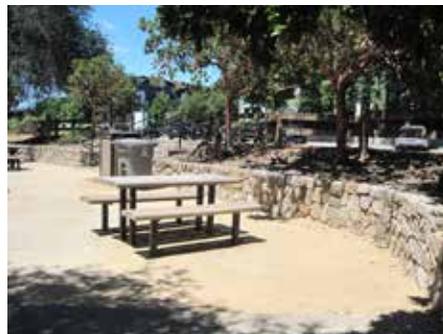
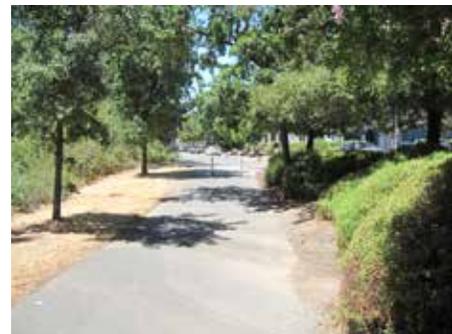
The overall condition of the park is good, and a majority of the amenities are in good condition. Trailhead Park does not have recreation programming, has moderate play value, and does not have non-compliant features identified by the 2013 and 2016 ADA assessments.

There are no amenities in critical condition at the park. However, the landscape areas require mulch replenishing.

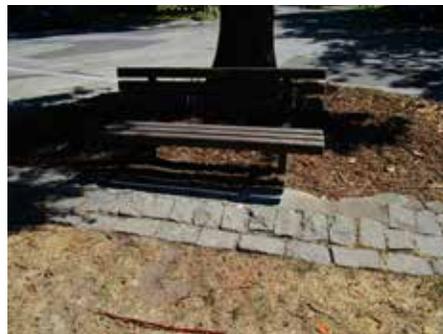
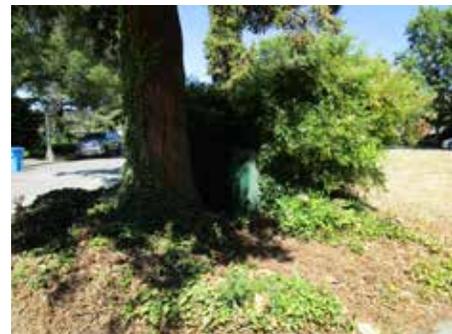
The overall condition of the park is good, and a majority of the amenities are in good condition. Triangle Park does not have recreation programming, has low play value, and does not have non-compliant features identified by the 2013 and 2016 ADA assessments.

There are no critical condition amenities within the park, but the natural turf is dead, potentially due to drought measures.

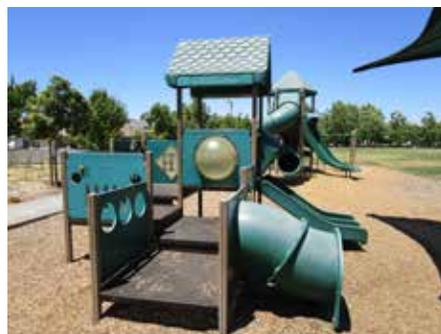
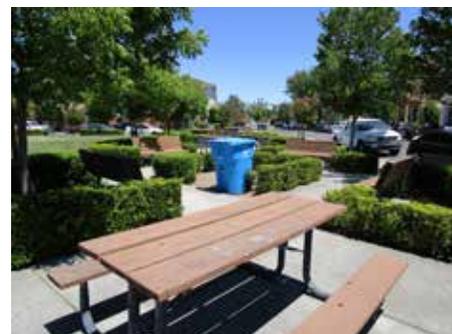
The overall condition of the park is adequate, and a majority of the amenities are fully functional. Village Green Park does not have recreation programming, has very high play value, and does not have non-compliant features identified by the 2013 and 2016 ADA assessment.

There are no critical condition amenities within the park, though a portion of the concrete pavement has significant cracking, and the quantity of trash receptacles throughout the park is deficient.

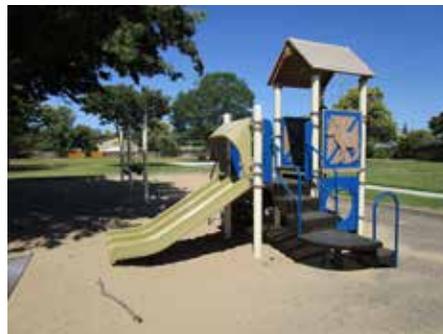
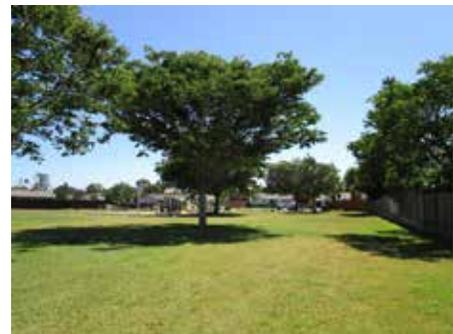
The overall condition of the park is adequate. Westgate Park does not have recreation programming, has very high play value, and has a few significantly non-compliant ADA elements.

There are no critical condition amenities within the park, though there are a few general amenities that are nearing the end of their life span, such as the bollards and park signage.

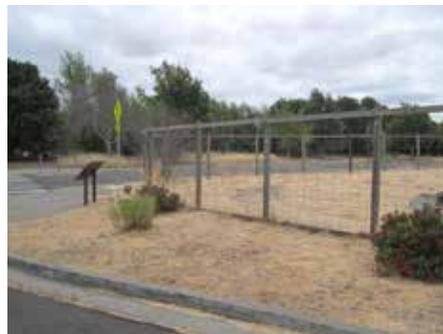
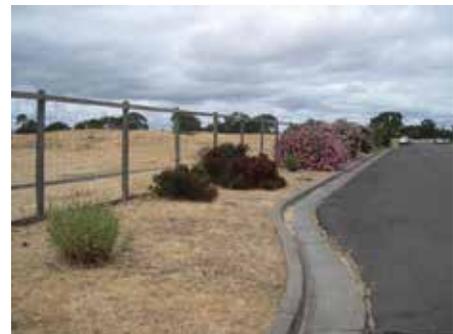
There are no critical condition amenities within the park. However, the locking mechanism for the entry gate is damaged.

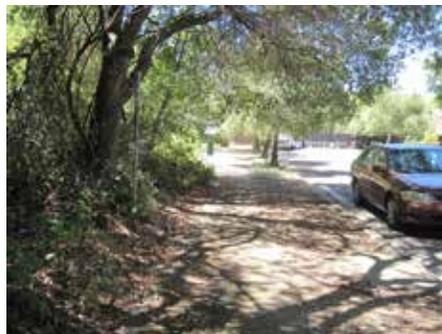
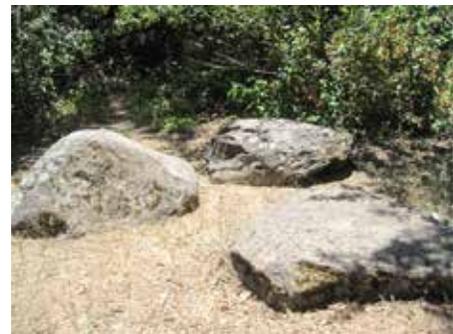
The critical condition amenities within the park is the irrigated groundcover landscape, which is weedy and partially dead.

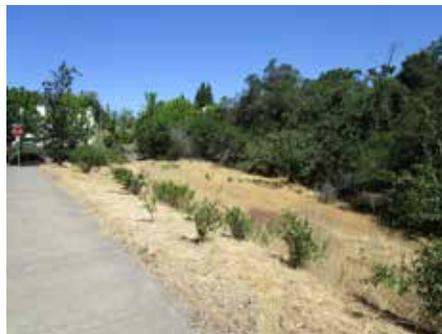
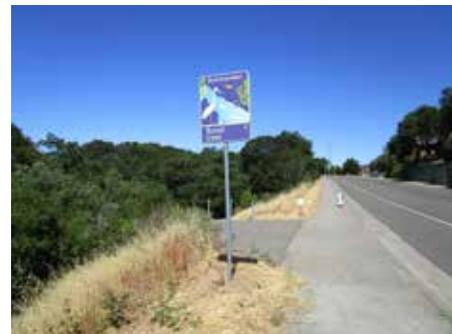
The critical condition amenities within the park are the natural landscape and signage. There were noxious weeds and a deficient amount of park signage.

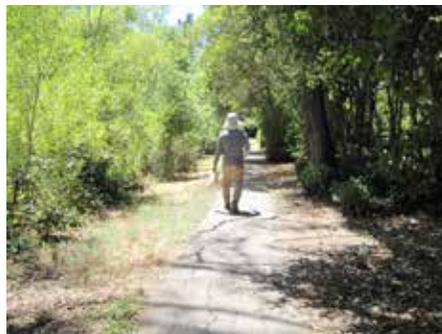
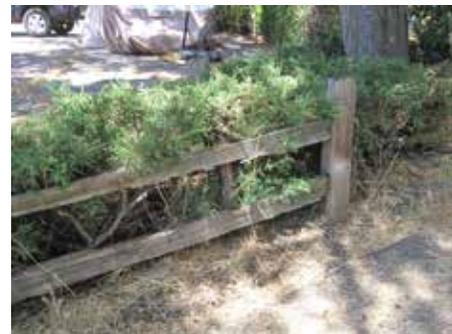
The critical condition amenity within the park is the asphalt pavement, which has major buckling across the surface.

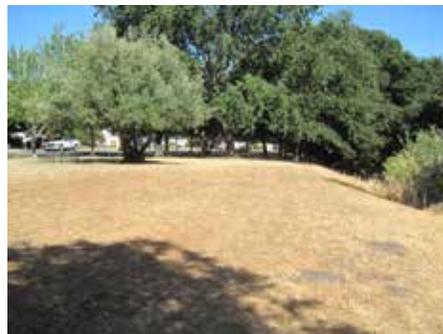
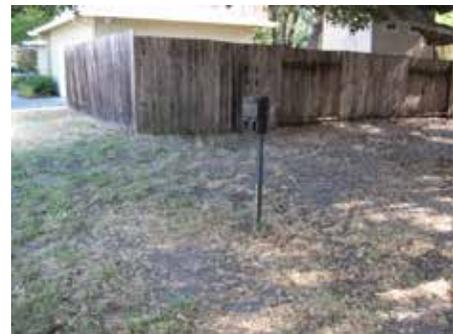
The park does not have critical condition amenities, though a trash receptacle has been damaged and is no longer functional.

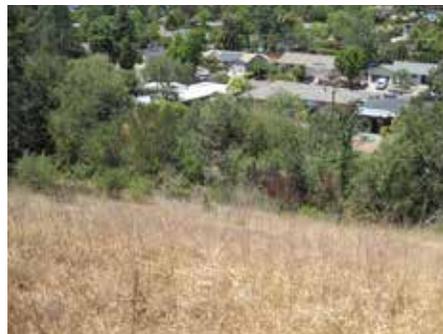
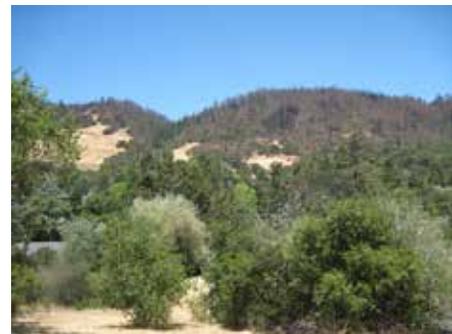
The critical condition amenity within the park is the natural landscape, which include portions of tall, overgrown grasses that pose a fire hazard and require mowing.

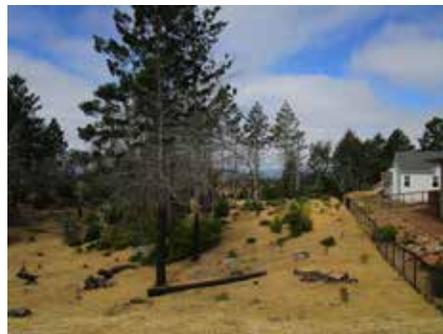
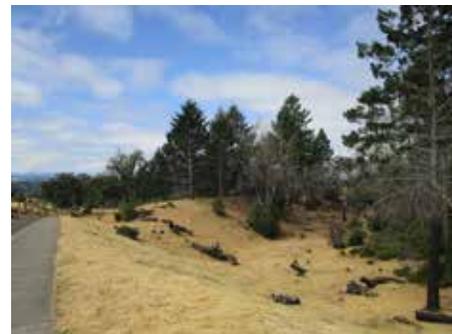
There are no amenities in critical condition at the park. However, a number of trees and portions of the landscape have been impacted due to fire damage from the 2017 wildfires.

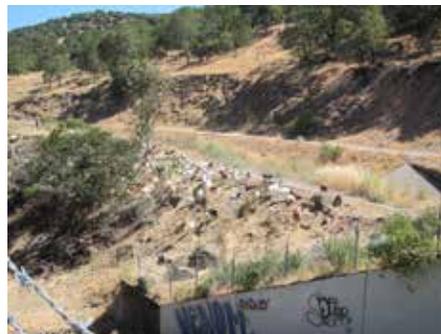
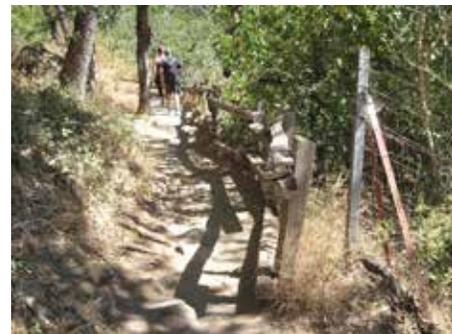
RANKING MATRIX - PARK TRAIL OPEN SPACE

The overall condition of the park is below adequate, primarily due to the trail condition. Parktrail Open Space does not have recreation programming, has moderate play value, and does not have non-compliant features identified by the 2013 and 2016 ADA assessment.

The critical condition amenities within the park are the trail and the site furnishings. The trail surface is uneven with frequent rocks and boulder obstructing the path, the site furnishings are severely worn, and the quantity of trash receptacles is deficient.
