City of
Santa Rosa

June 10, 2022

PARKS

PRIORITIZATION REPORT

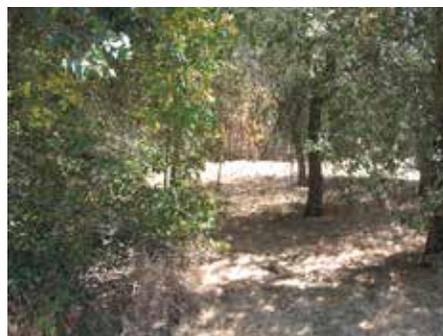
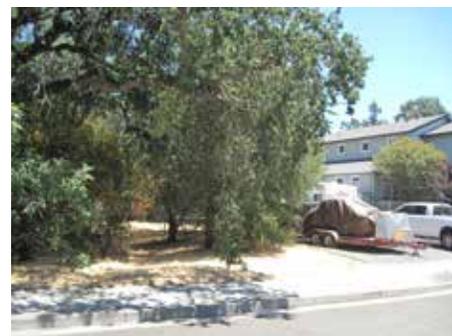
RANKING MATRIX - SKYHAWK CREEK OPEN SPACE

The overall condition of the park is adequate. Skyhawk Creek Open Space does not have recreation programming, has low play value, and does not have non-compliant features identified by the 2013 and 2016 ADA assessments.

There are no amenities in critical or poor condition at the park. However, a number of trees have been impacted due to fire damage from the 2017 wildfires.

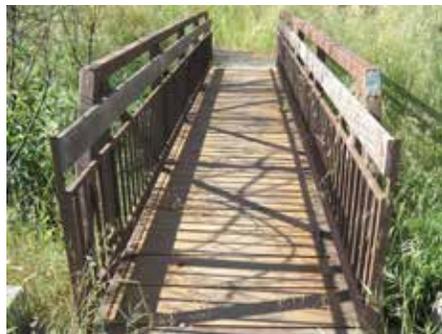
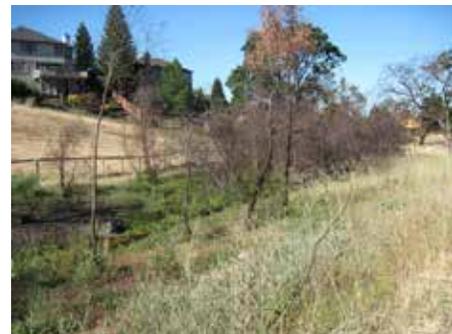
RANKING MATRIX - SKYHAWK OPEN SPACE

The overall condition of the park is good. Skyhawk Open Space does not have recreation programming, has low play value, and does not have non-compliant features identified by the 2013 and 2016 ADA assessments.

There are no amenities in critical or poor condition at the park. However, a number of trees have been impacted due to fire damage from the 2017 wildfires.

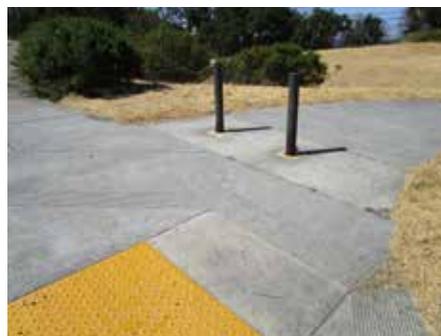
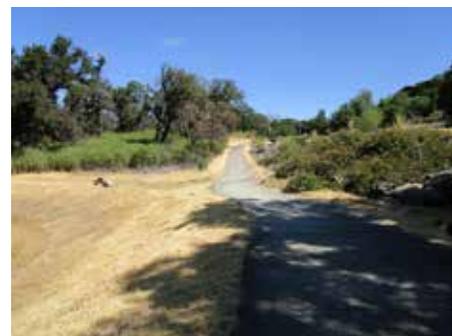
RANKING MATRIX - THOMAS LAKE HARRIS OPEN SPACE

The overall condition of the park is adequate, and a majority of the amenities are fully functional. Thomas Lake Harris Open does not have recreation programming, has low play value, and does not have non-compliant features identified by the 2013 and 2016 ADA assessments.

The critical condition amenity within the park is the general landscape due to the dense invasive plants observed within the natural landscape.

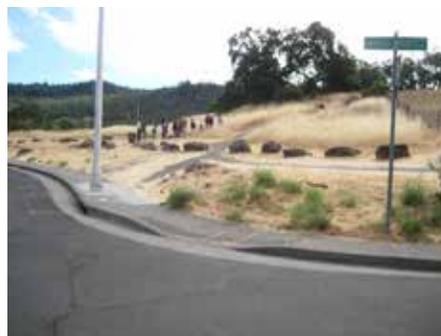
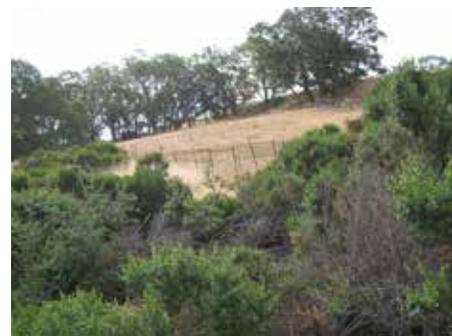
RANKING MATRIX - VIETNAM VETERANS MEMORIAL TRAIL

The overall condition of the park is adequate, a with a few site furnishings in poor condition. Vietnam Veterans Memorial Trail does not have recreation programming, has moderate play value, and does not have non-compliant features identified by the 2013 and 2016 ADA assessment.

The critical condition amenities within the park are the site furnishings. Site furnishings are severely worn, and the quantity of trash receptacles is deficient.

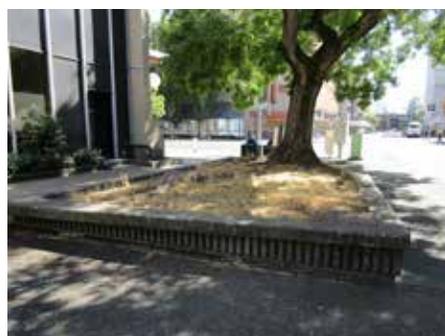
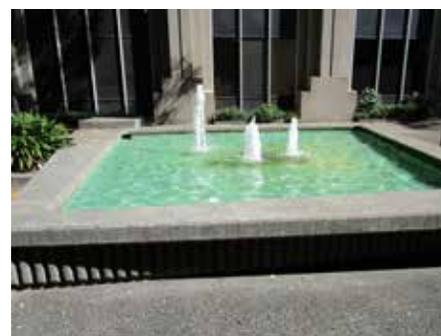
RANKING MATRIX - COMSTOCK MALL

The overall condition of the park is adequate, and a majority of the amenities are fully functional. Comstock Mall does not have recreation programming, has low play value, and does not have non-compliant features identified by the 2013 and 2016 ADA assessments.

The critical condition amenity within the park is the irrigation system, which does not appear to be operational.

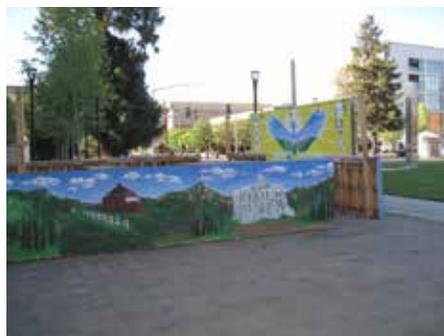
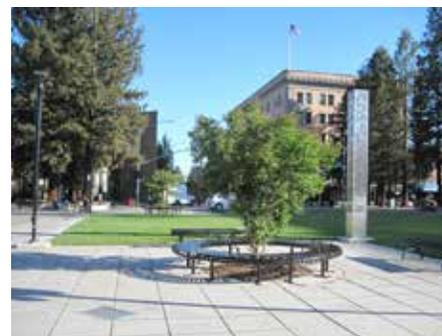
RANKING MATRIX - COURTHOUSE SQUARE

The overall condition of the park is very good, a majority of the amenities are functional, and the park is not anticipated to need major improvements in the near-term. Courthouse Square does not have recreation programming, has low play value, and does not have non-compliant features identified by the 2013 and 2016 ADA assessments.

There are no critical condition amenities at the park.

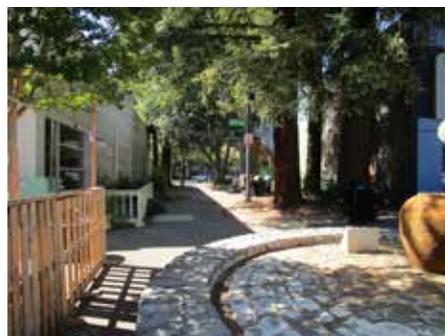
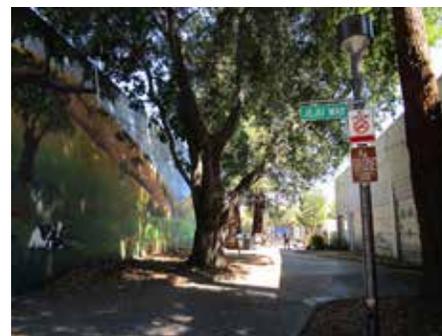
The overall condition of the park is adequate, and a majority of the amenities are fully functional. Jeju Way does not have recreation programming, has low play value, and does not have non-compliant features identified by the 2013 and 2016 ADA assessments.

The park does not have critical condition amenities, though a number of broken irrigation heads were identified and do not appear to be functional.

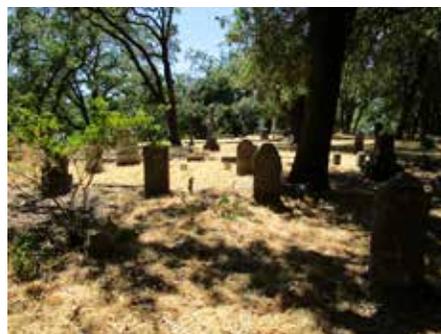
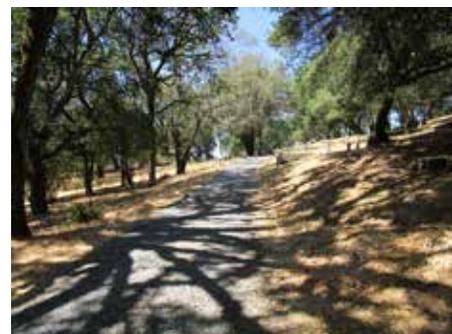
The overall condition of the park is good, and a majority of the amenities are in good condition. Santa Rosa Rural Cemetery does not have recreation programming, has low play value, and generally complies with ADA standards with only a few minor non-compliant items.

There are no amenities in critical condition except for the general furnishings due to a deficient quantity of trash receptacles.

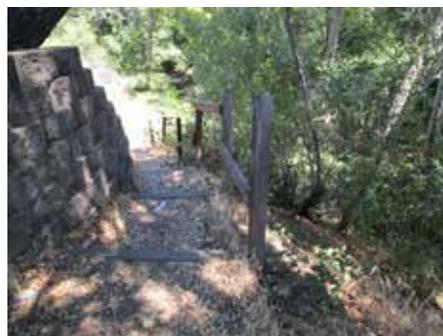
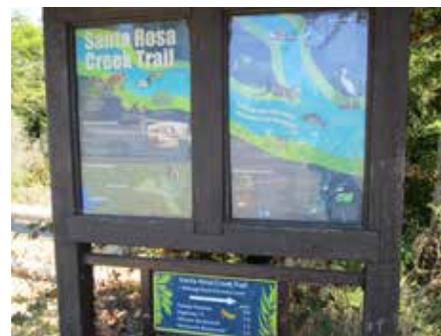
The overall condition of the park is adequate, aside from a few deficient amenities. Fourth and Farmers Creek Trail does not have recreation programming, has moderate play value, and does not have non-compliant features identified by the 2013 and 2016 ADA assessment.

The critical condition amenity within the park is the trail, where portions of the dirt surfacing are substantially uneven and concrete debris obstructs the path.

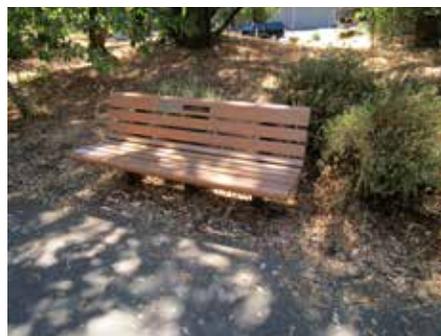
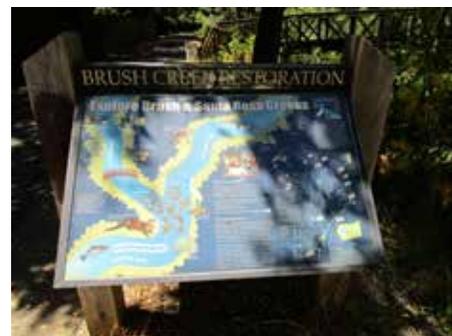
The overall condition of the park is below adequate. Hampton Woods Trail does not have recreation programming, has moderate play value, and does not have non-compliant features identified by the 2013 and 2016 ADA assessment.

The critical condition amenities within the park are the site furnishings due to a deficient quantity of trash receptacles, and the irrigation, which does not appear to be operational.

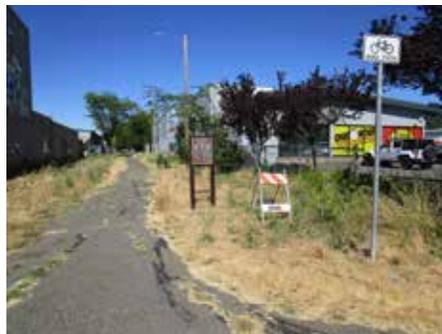
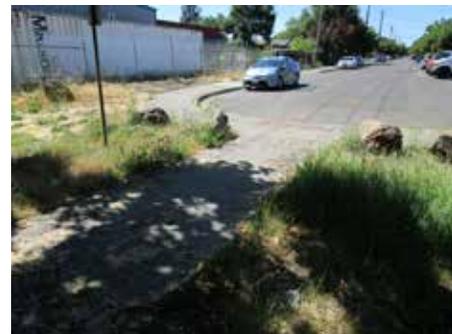
The overall condition of the park is below adequate due to the trail condition. Newhall Bike Trail does not have recreation programming, has moderate play value, and does not have non-compliant features identified by the 2013 and 2016 ADA assessments.

The critical condition amenity within the park is the hardscape, which has severe cracking and weed growth within the pavement.

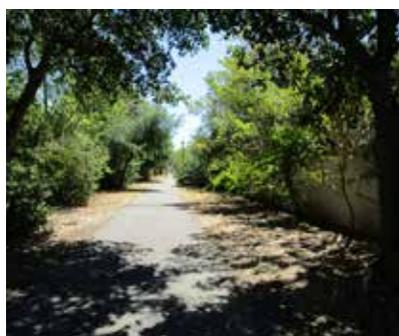
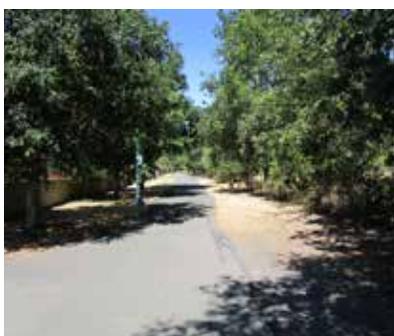
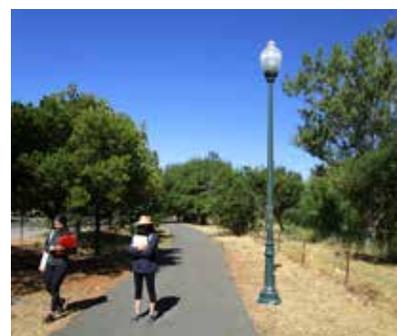
The overall condition of the park is adequate, and a majority of the amenities are fully functional. Pearblossom Trail does not have recreation programming, has moderate play value, and has moderate non-compliant ADA features based off the of the condition ranking.

The park does not have critical condition amenities, though there are portions of the ornamental landscape that are dead or missing, and the spray irrigation for the natural turf has coverage issues.

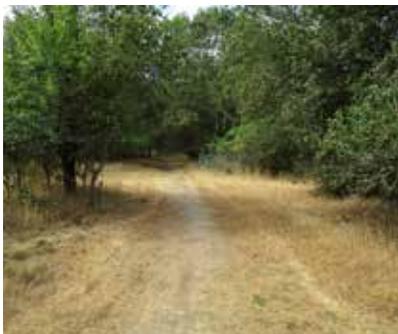
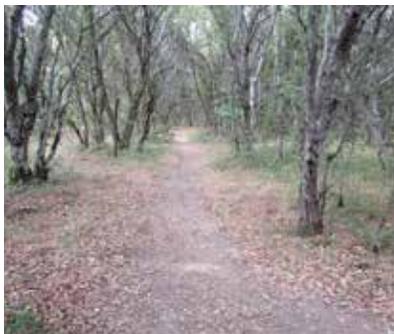
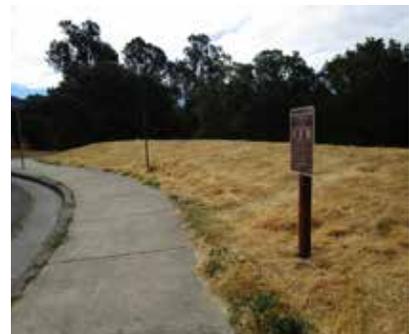
The overall condition of the park is adequate. Upper Brush Creek Trail Park does not have recreation programming, has moderate play value, and does not have non-compliant features identified by the 2013 and 2016 ADA assessments.

The critical condition amenity within the park is the trail due to a number of holes throughout the park, a lack of signage, and the informal bike jumps created near Wild Lilac Lane.
