# Restoring Water Service to the Advisory Area

Board of Public Utilities Meeting  
September 20, 2018

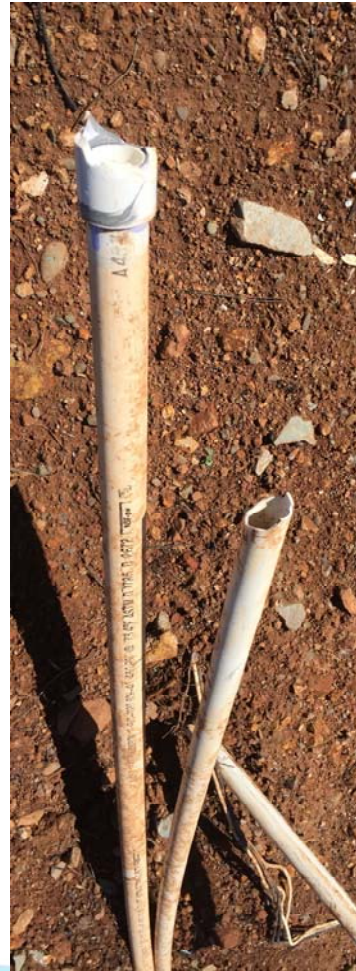
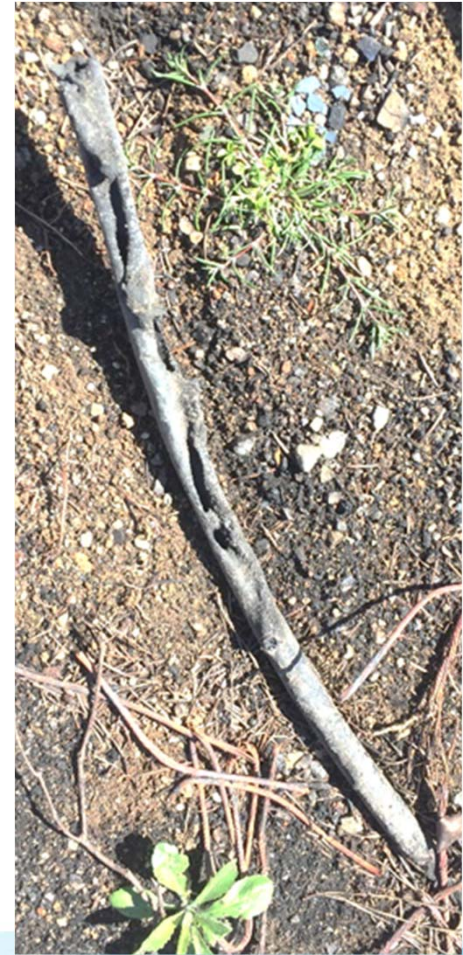
- Melting and burning of plastics
- Smoke, soot, and ash
- Adhered and absorbed into water services and system components
