7 September 2018

# Evaluation of City Water System's Response in Fountaingrove to the October 2017 Fire

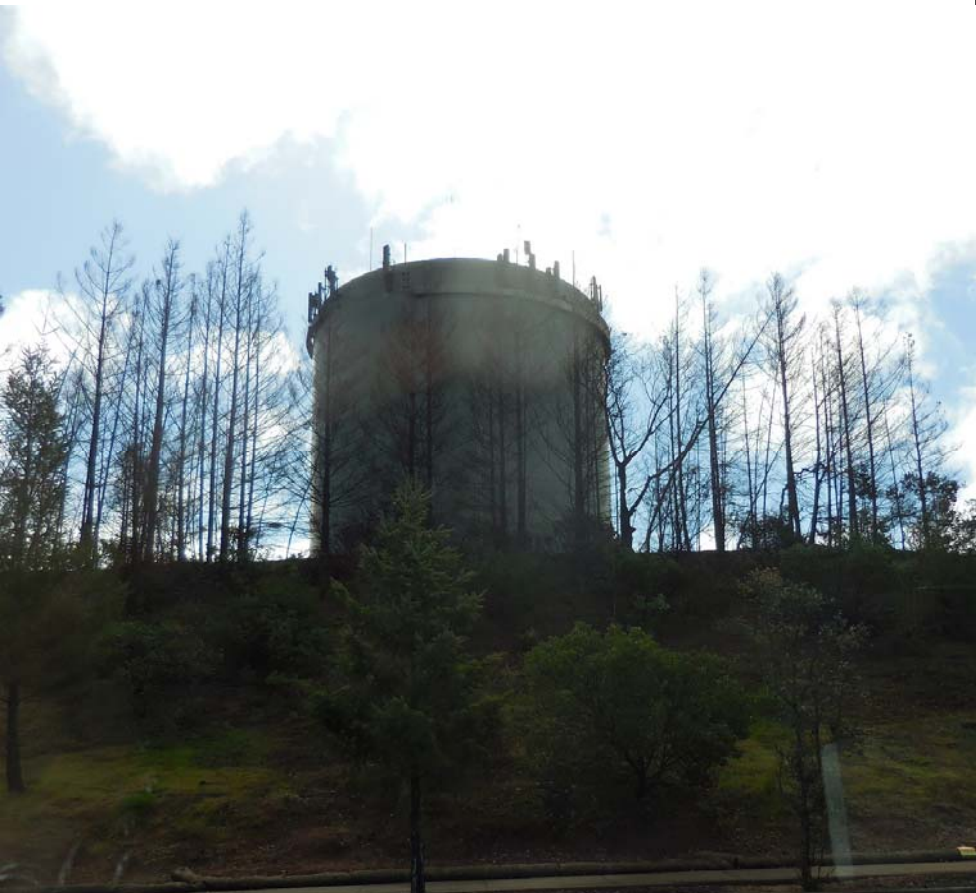
## Conclusions

- **Water distribution system operated as designed and meets fire flow goals**
- **System was pumping, where there was suction head, but could not regain tank levels until flowing pipes were shut-off**
