John and Lynn Rodgers 818 Monroe Street AP 180 680 036 Project Description

Minor Landmark Alteration

Existing 484 downstairs habitable space has been increased to 862 and this additional habitable space of 378 sft ft is what we are trying to legalize. It is a living room at the rear of the house that basically it is not visible from the streets.

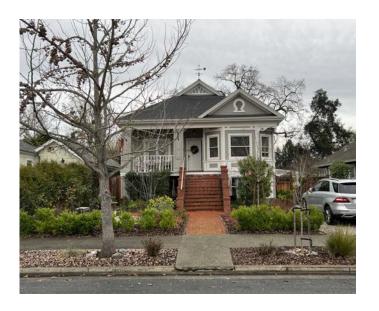
### Picture 1-A

This is the front of 818 Monroe Street. Built in 1900. Paint color is Benjamin Moore Abbey Road, a blend of gray and beige. White trim.

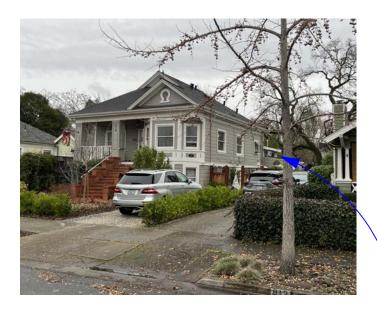
## Picture 1-C

This is the street view from the south side of the property. You can not see anything of the addition except for a section of wall supporting a roof with two clear glass windows and you would have to be looking closely. There is an air conditioner unit on the roof which may or may not work but again, it was not something the owner did, and they plan on removing it as they complete this project.

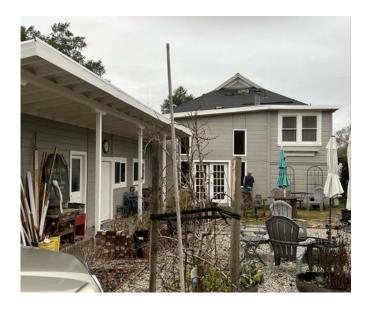
### Picture 2-A

This shows the actual addition outline in red. The view is from inside a fence along the alley which runs between the backyards. Most of it is not seen from the alley because of this fence. There are no adjacent streets close enough for a view of any of this.

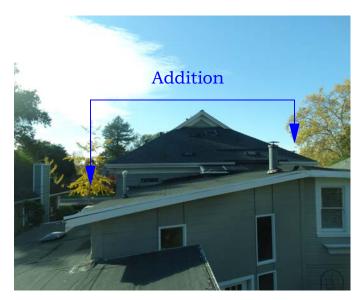
### Picture 2-C

A closer view. These windows and this door will be replaced. White vinyl will be the material. We plan to add 1x 4 trim and a sill to match the window you see on the right which is on a legal part section of the building. Siding is a plywood panel with grooves which gives a resemblance to the homes existing siding. These windows and doors are not visible from anywhere.

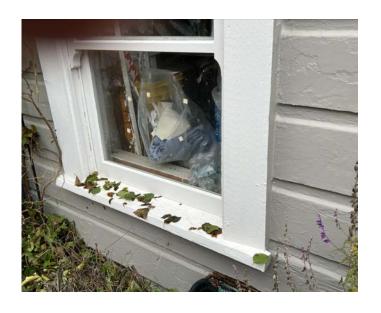
## Picture 3-A

This is a sample of the window, trim and sill. The new windows in the addition will be trimmed similarly. Since they are out of sight, the frames will be white vinyl.

Benjamin Moore Abbey Road, a blend of gray and beige. White trim. Roofing is black torchdown for low slope roofing.

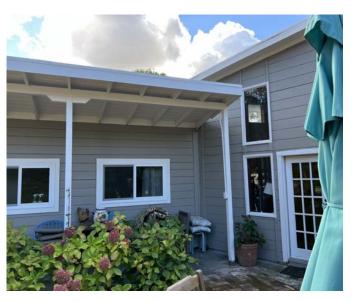
#### Picture 3-B

The windows on the right will be trimmed similar to the window above. The lower windows will be single hung of the same size and will open. The other windows above will remain as clear glass and be trimmed similar to the window above. You can also see that the soffit is enclosed which was typical of the style in the 1900's and is consistent with the rest of the home. The newer legal addition on the right has an open rafter style over the walkway.
